Ball Joint Bearing Failure

Socket Design

www.moogproblemsolver.com

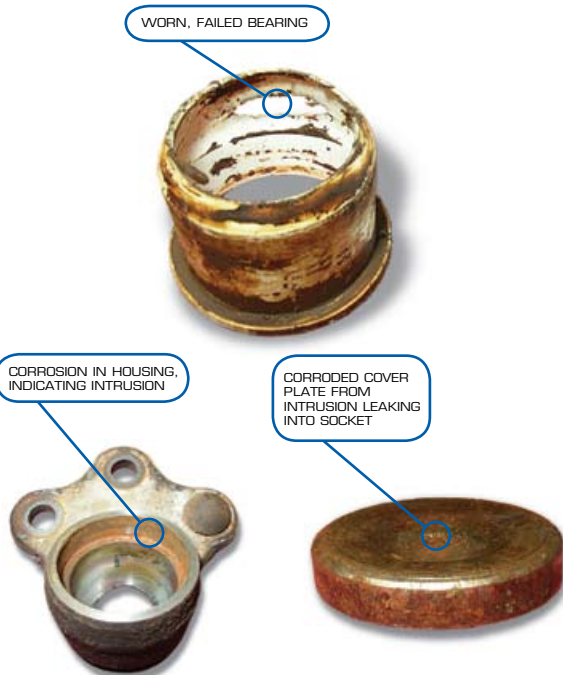
PROBLEM:

Premature failure/excessive play/joint separation

- Non-serviceable socket design cannot flush contaminants from the assembly, causing corrosion and wear.
- Boot deterioration/failure can lead to lubrication loss. The bearing quickly wears, resulting in excessive deflection, imprecise steering/alignment and possible assembly separation.
- Plastic bearings do not uniformly transmit force into the wall of the housing and cover plate, causing deformation and wear. This affects steering stability and results in shorter service life.

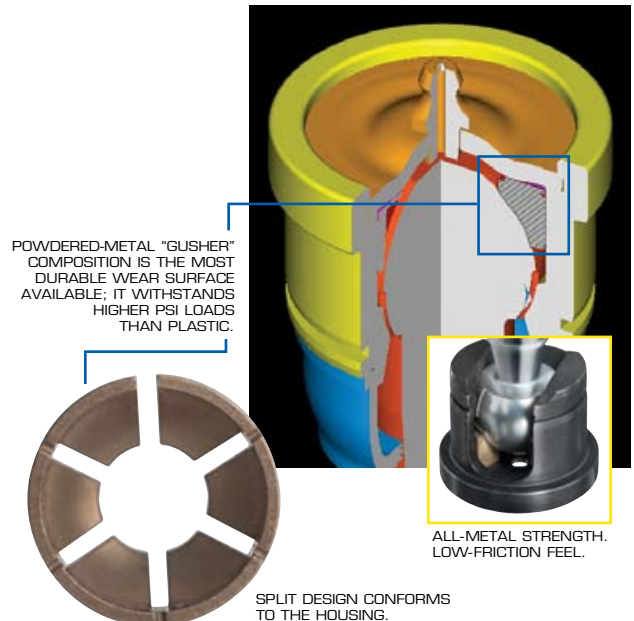
SOLUTION:

MOOG® Premium bearing design

- Serviceable MOOG socket design allows new lubricant to flush contaminants away from the bearing/full-ball metal stud assembly.
- Hardened, powdered-metal “gusher” bearings are not prone to the excessive wear that plastic bearings suffer under unfavorable conditions.
- Powdered-metal bearing construction withstands higher psi loads without deformation.
- MOOG bearings fit tightly against the housing, allowing them to transfer vehicle loads to the housing. This diminishes load forces and reduces stress.
